Fire safety issues with balconies

Case study 1 – Block of flats, July 2010

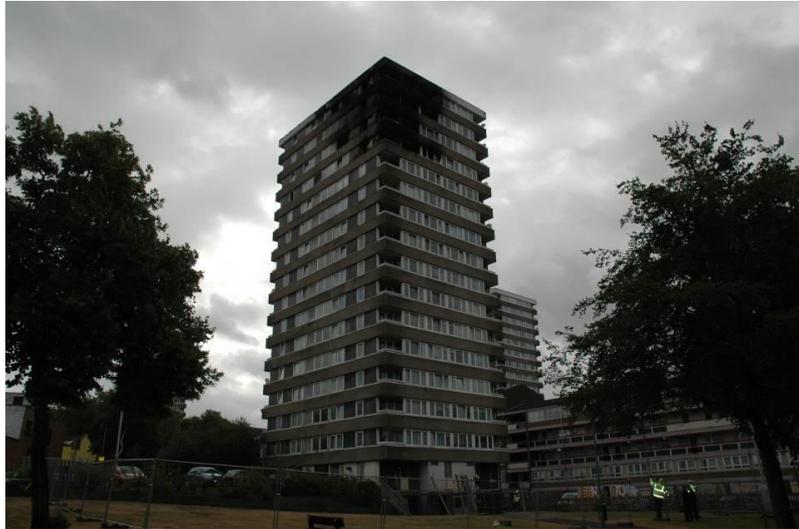
A deliberate fire was started on the balcony of a 12th floor flat of a 16-storey residential block of flats constructed in the 1960s. As can be seen from Figure 1, the fire spread from the balcony of origin to the 15th floor and the roof of the building. Several features of the building were attributed to the extent of fire spread including combustible insulating panels (which were clad onto the underside of all of the balconies), cladding panels (which had been installed onto the outer surface of the exterior wall and comprised a mineral fibre board face supported on timber battens, behind which there was a fibrous combustible insulation material) and plastic drain pipes (which were installed at each corner of the building and passed through the concrete floor slab on each floor). There was no evidence of any fire stopping, proprietary seal or sleeve where the

pipe passed through the floor slab in the balcony which should have been provided to maintain the level of fire resistance afforded by the concrete floor slab.

Figure 1 – Block of flats showing extent of fire damage caused by holes in compartmentation on balconies

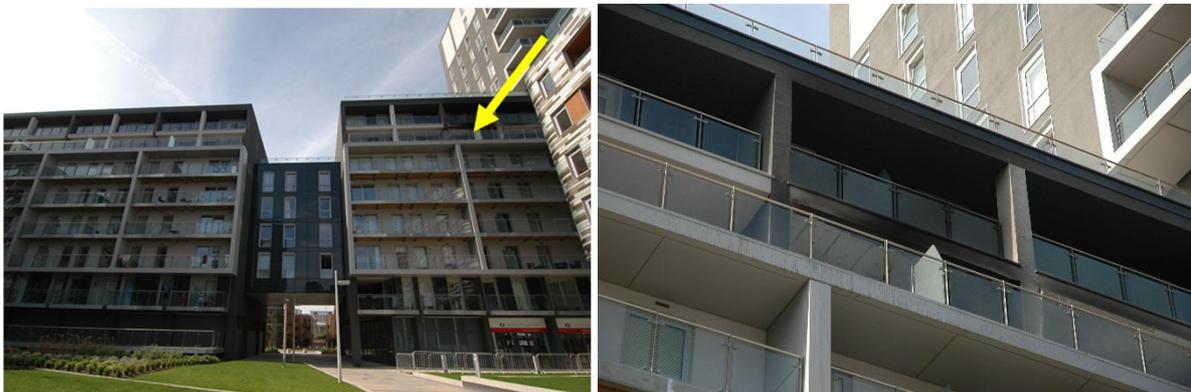
A fire started on a balcony on the sixth floor of an eight and 16-storey purpose built block of flats constructed circa 2009 (Figure 2). The fire was caused by misuse of smoking materials; a plastic cup had been used as an ashtray and the lit cigarette had ignited the balcony components. The block was predominately of concrete construction with external surfaces covered in a variety of cladding systems, with cavities filled with a variety of rigid foam insulation. The construction detail of the balconies in the development seemed to vary; the balcony of fire origin appeared to be supported on an extension of the concrete floor slab of the main building structure but other balconies were timber built into the structure. The floor of the balcony was covered with timber decking on timber battens supported on polyethylene spacer rings. The spacer rings were, in turn, situated on a layer of foam insulation covered with a woven plastic sheet. It is this plastic sheet which is understood to have ignited and this, in turn, ignited the foam insulation under the decking. The fire spread under the decking consuming the foam insulation and also spread to involve insulation behind cladding systems on external walls. The fire also involved the ceiling of the balcony which had an expanded polystyrene insulation behind a render. The fire spread to the balcony of the neighbouring flat on the same level under the decking. There were no reported injuries as a result of the incident.

Figure 2 – Extent of damage to balcony, left, indicated by arrow and close-up view right
